BETHLEHEM TOWNSHIP

ARCHIBALD JOHNSTON MANSION STABILIZATION STUDY

JANUARY 2016

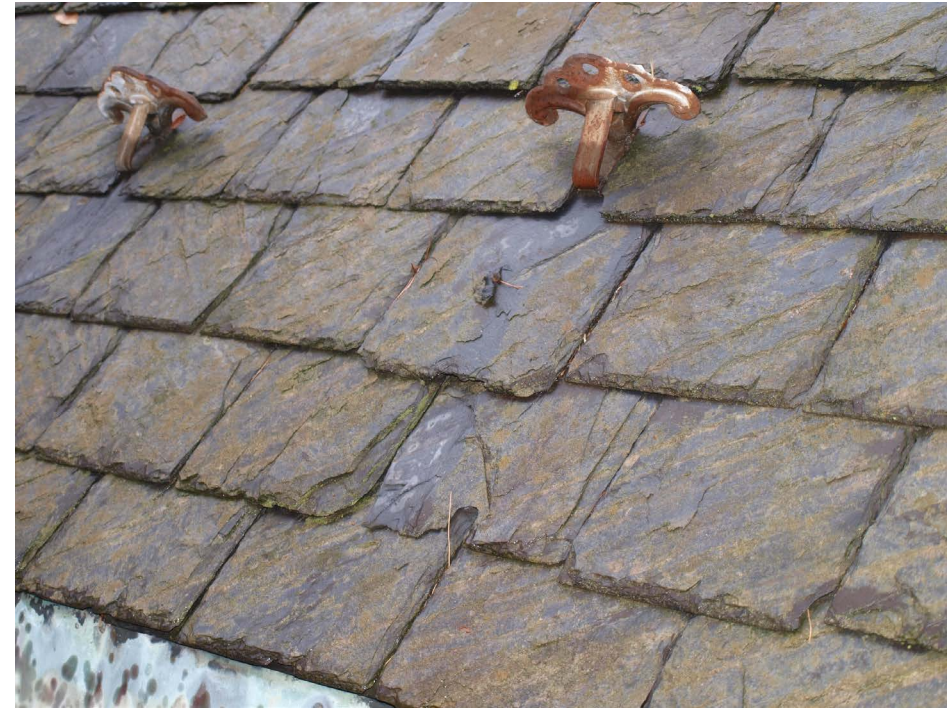
3. The slates appear to be the original slates and are beginning to deteriorate (spall). This deterioration is normal for this type of slate, however the deterioration of the slates will continue. Fig A

9. The snow guards appear to be galvanized steel. Fig. A
10. The chimney tops are in extremely poor condition, and are allowing large amounts of moisture into the building. Fig. F

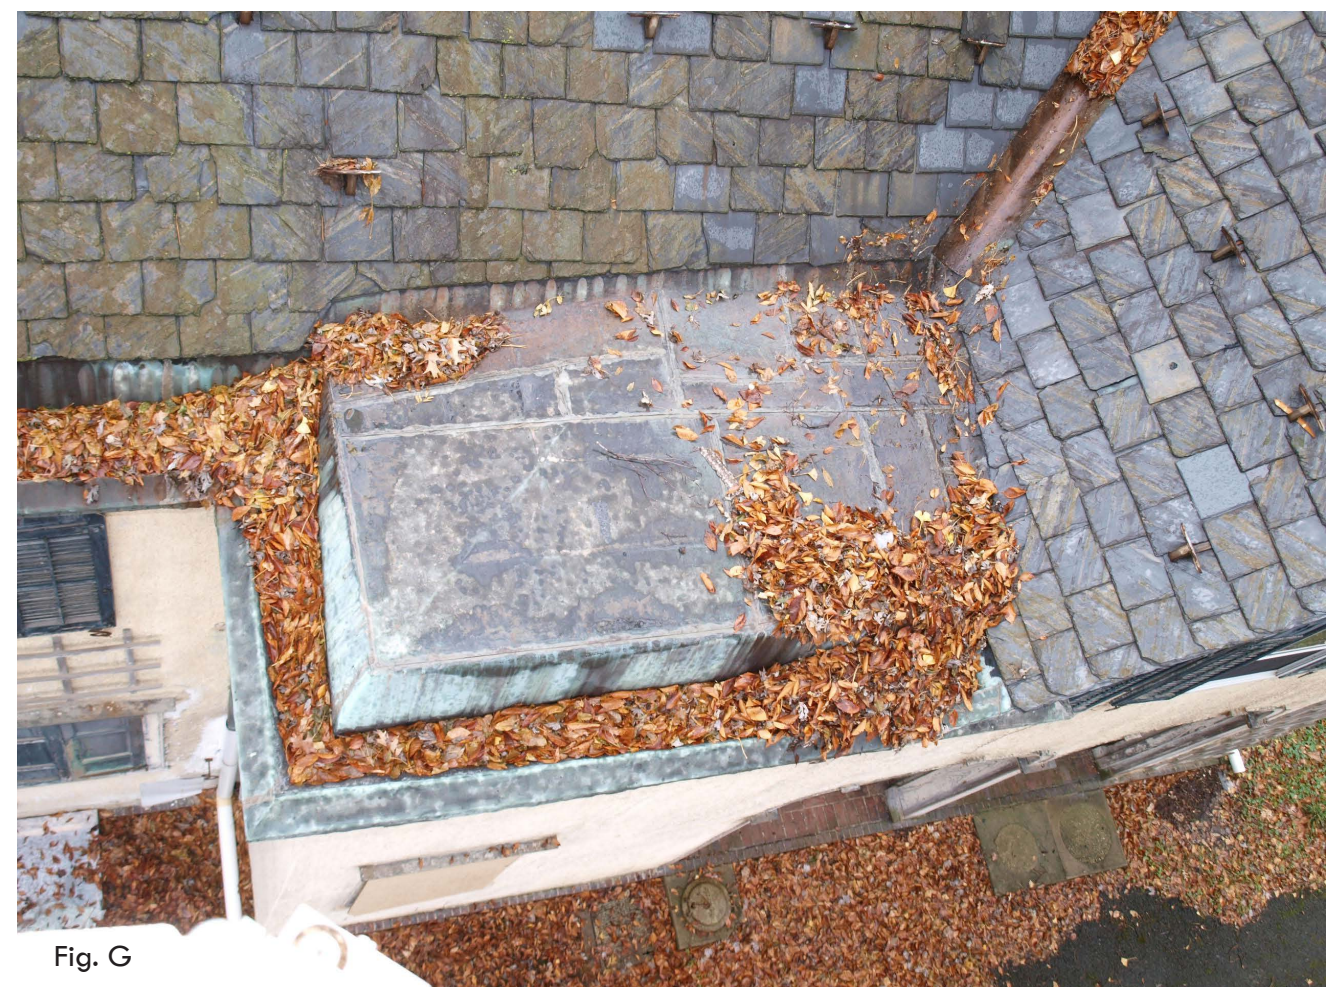
Fig. G

11. The flat areas of the roof are flat seamed copper, with solder joints. Figs. G and H
12. The flat seam roofing sections appear to be in fair condition. But soldered seams can have pin holes which allow moisture to penetrate causing damage which is undetected from the exterior.

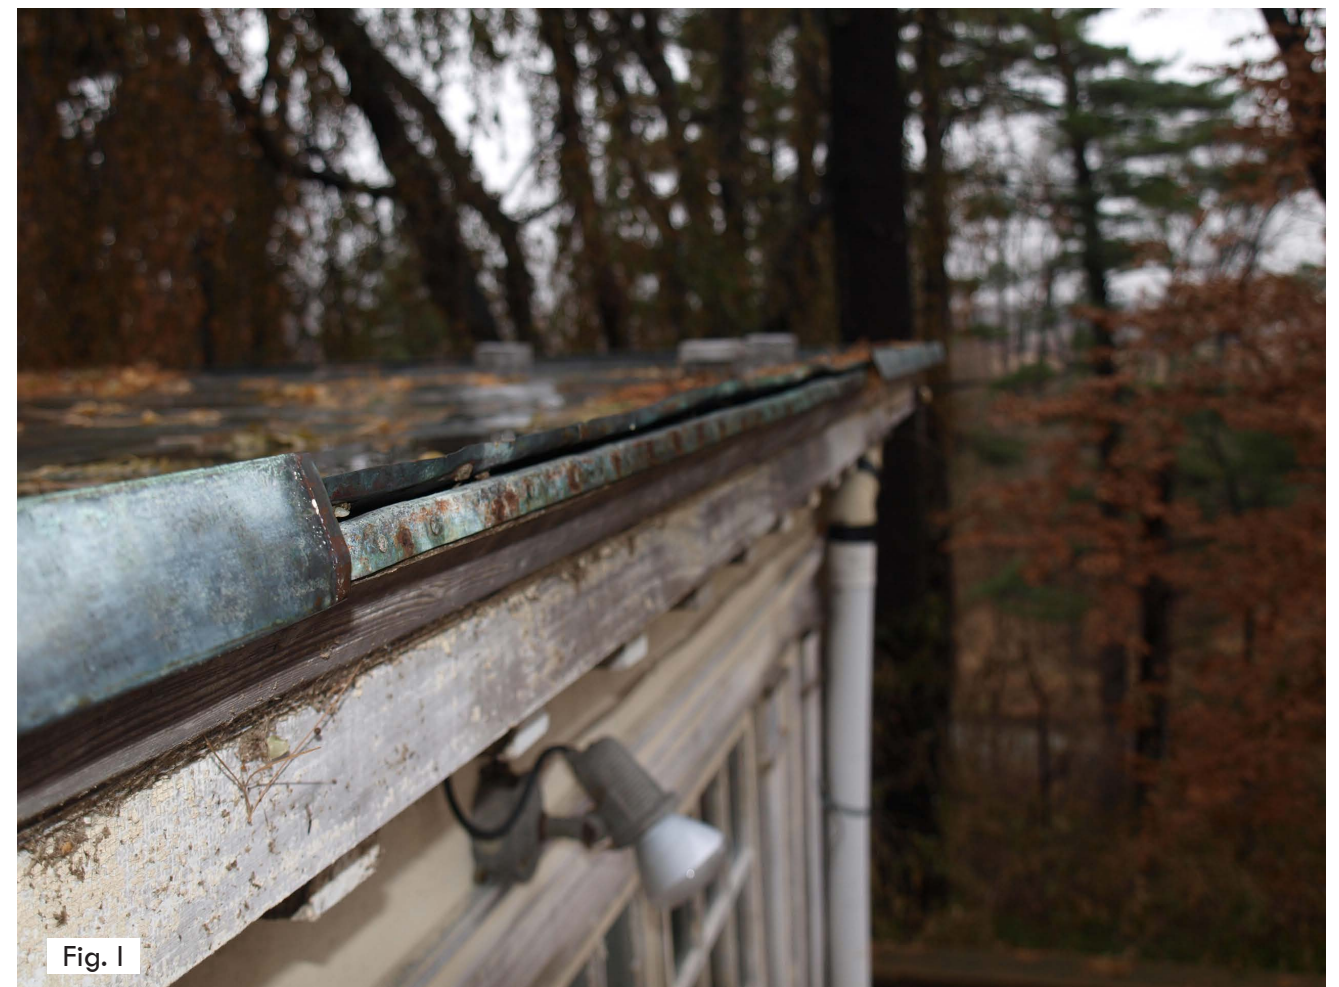
13. There is some critical roof edge flashing sections missing on the flat roof area. Fig. I
14. The drip edge on the flat roof area is not conducive to shedding the water away from the wood trim immediately below the roof. Fig. I

- a. Repair soldered seams of flat roof areas
- b. Repair flashing
- c. Repair gutter; or line gutter in another material
- d. Repair soffits
- e. Replace any existing metal edge sections that are missing or damaged.

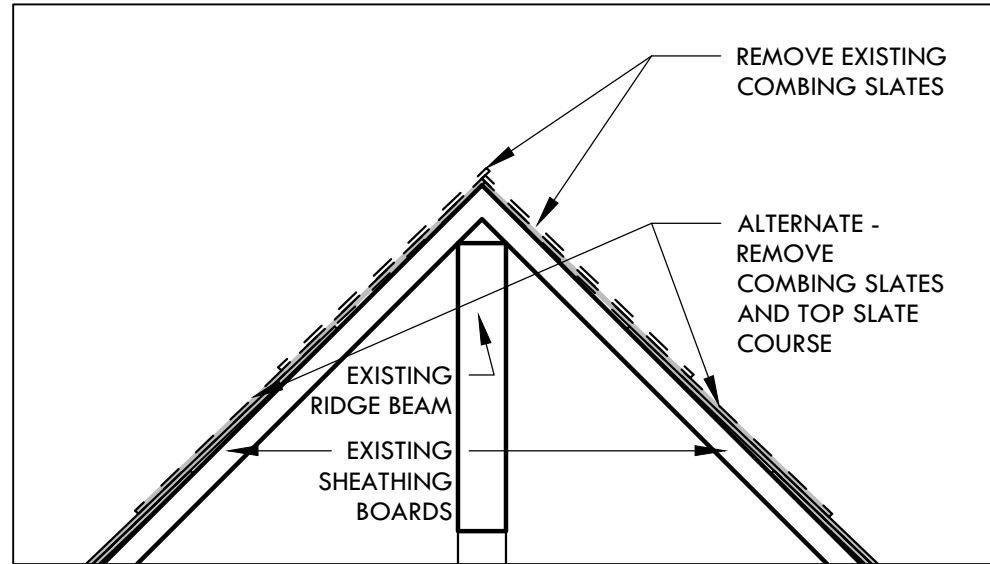
1 I.A. EXISTING "COMB RIDGE" DETAIL
 1 1/2" = 1'-0"

5. The slate ridge appears to be a "Comb Ridge" style which was common for that period. It is not necessarily a very watertight detail. We are certain that this ridge is allowing moisture to enter the roof assembly at this point; daylight can be seen from the interior through the ridge of the primary roof. Rendering this detail watertight is critical. Fig. C

The slate roof utilizes a “comb ridge” that is devoid of flashing and underlayment. The ridge is protected from water infiltration by only the slight overhang of one slate that extends over the ridge and a bead of asphalt cement, to which the opposite slate abuts at its underside. This detail is not watertight, and is providing water entry directly to the interior. In portions of the primary roof, daylight can be viewed through the ridge.

Prior to addressing the ridge, any damaged or missing slate shingles, approximately 50 in count, should be replaced. In order to prevent water infiltration through the ridge, a copper ridge cap can be used to replace the “comb ridge” without replacing the roof. The combing slates along the ridge would first be removed, and a copper ridge cap would be installed in their place. The basis of design is B&B Sheet Metal, straight ridge cap.

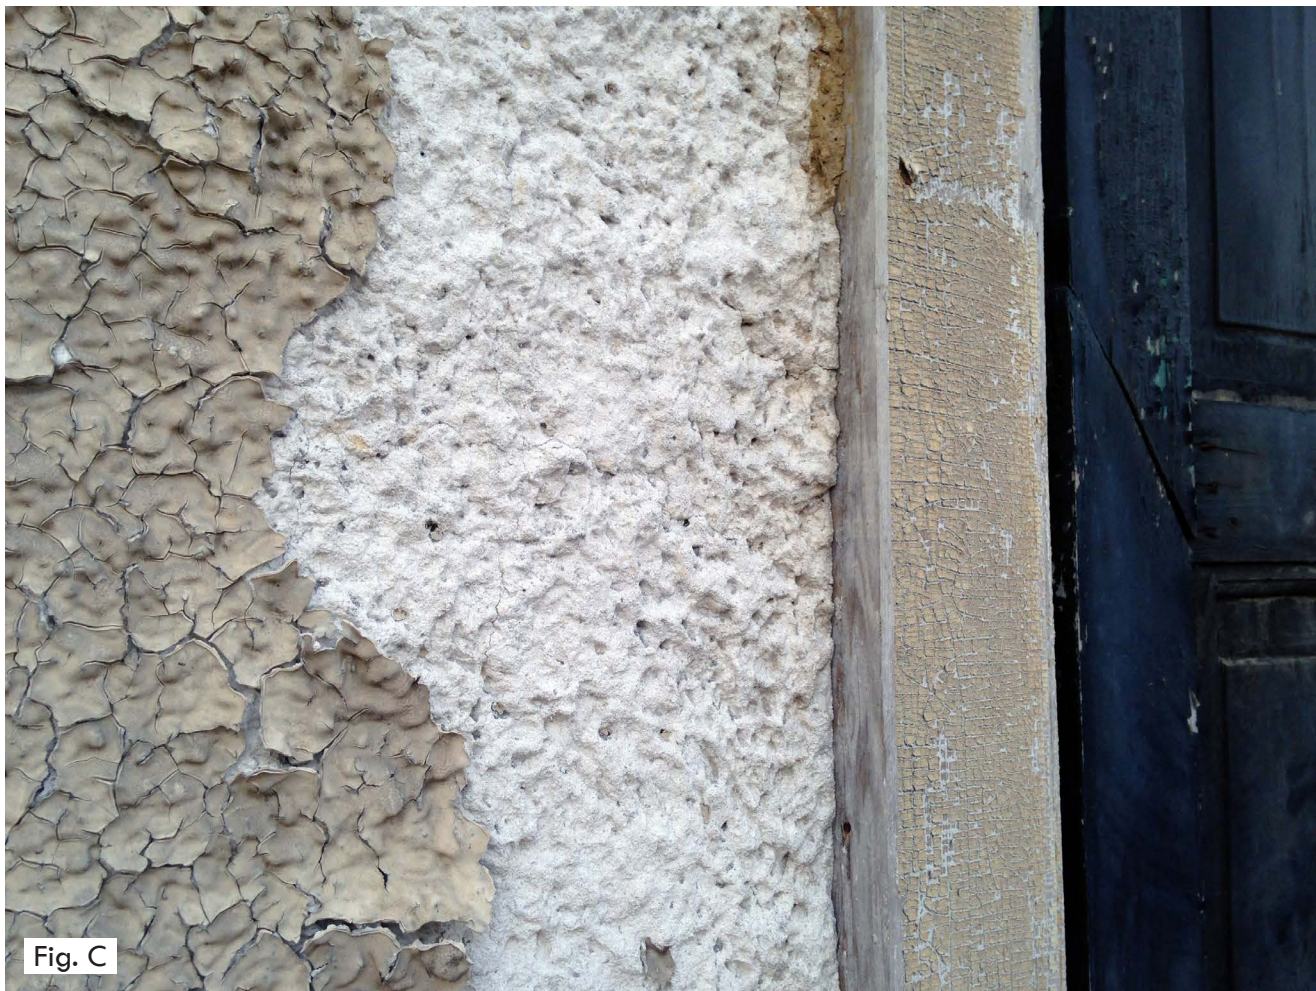
Fig. C

3. Both the brick veneer and the stucco have been installed in direct contact with the wood trim on the building including doors and windows. The contact between the dissimilar materials has produced cracks from the variances in expansion and contraction. These areas are allowing water to infiltrate the façade. FIG B and C

- a. Clear joint, between stucco and wood, of loose debris.
- b. Prime surface.
- c. Provide a continuous bead of sealant around openings and trim.

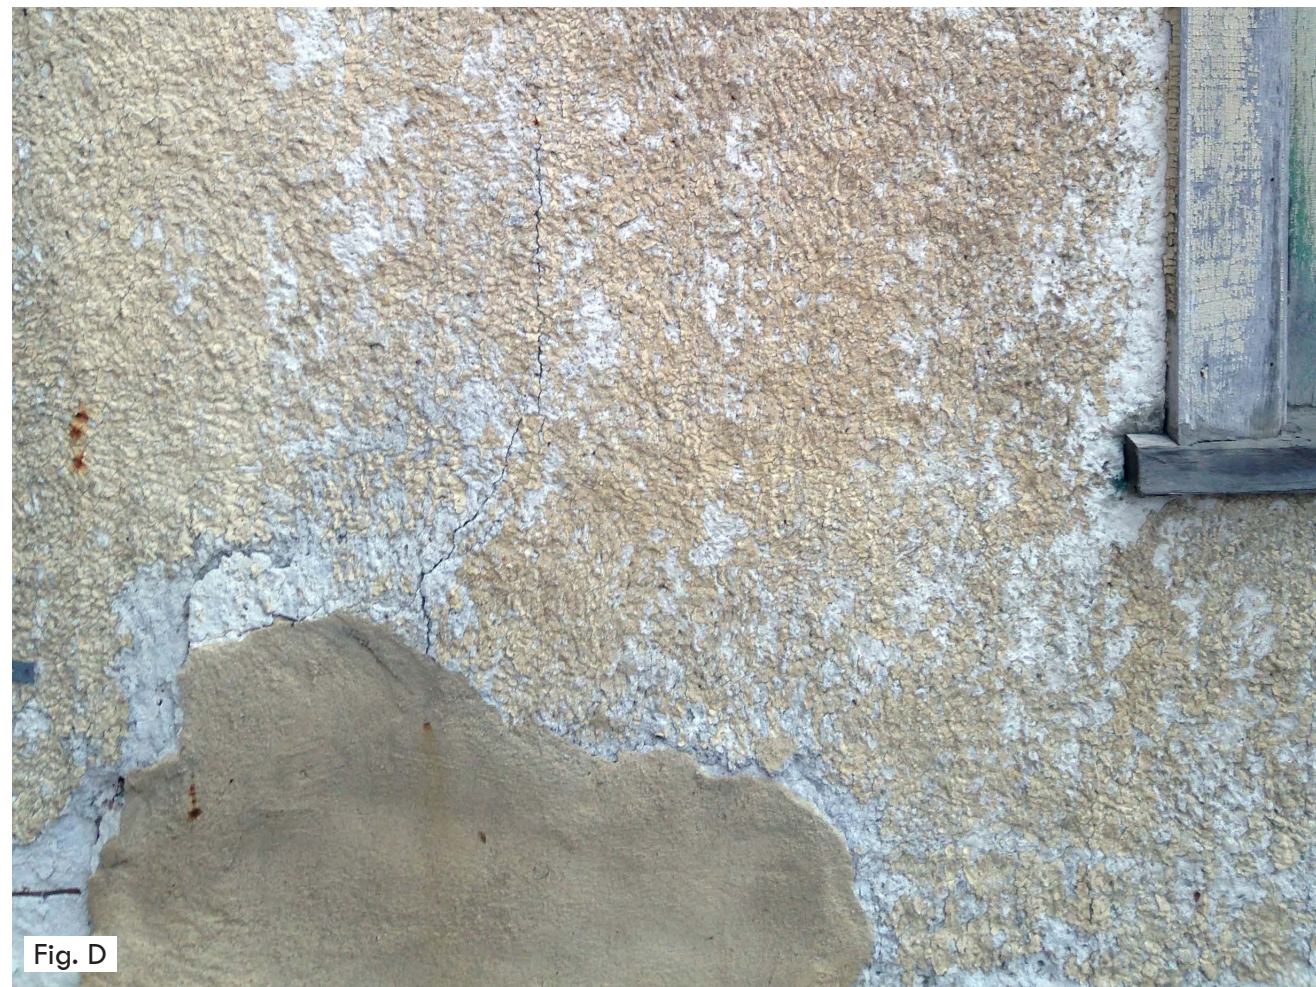
Fig. D

4. Stucco failures have been patched either with sheet metal, plywood, or cement plaster, preventing rodent infiltration and some water infiltration. The result is an irregular surface and varied appearance. FIG D and E

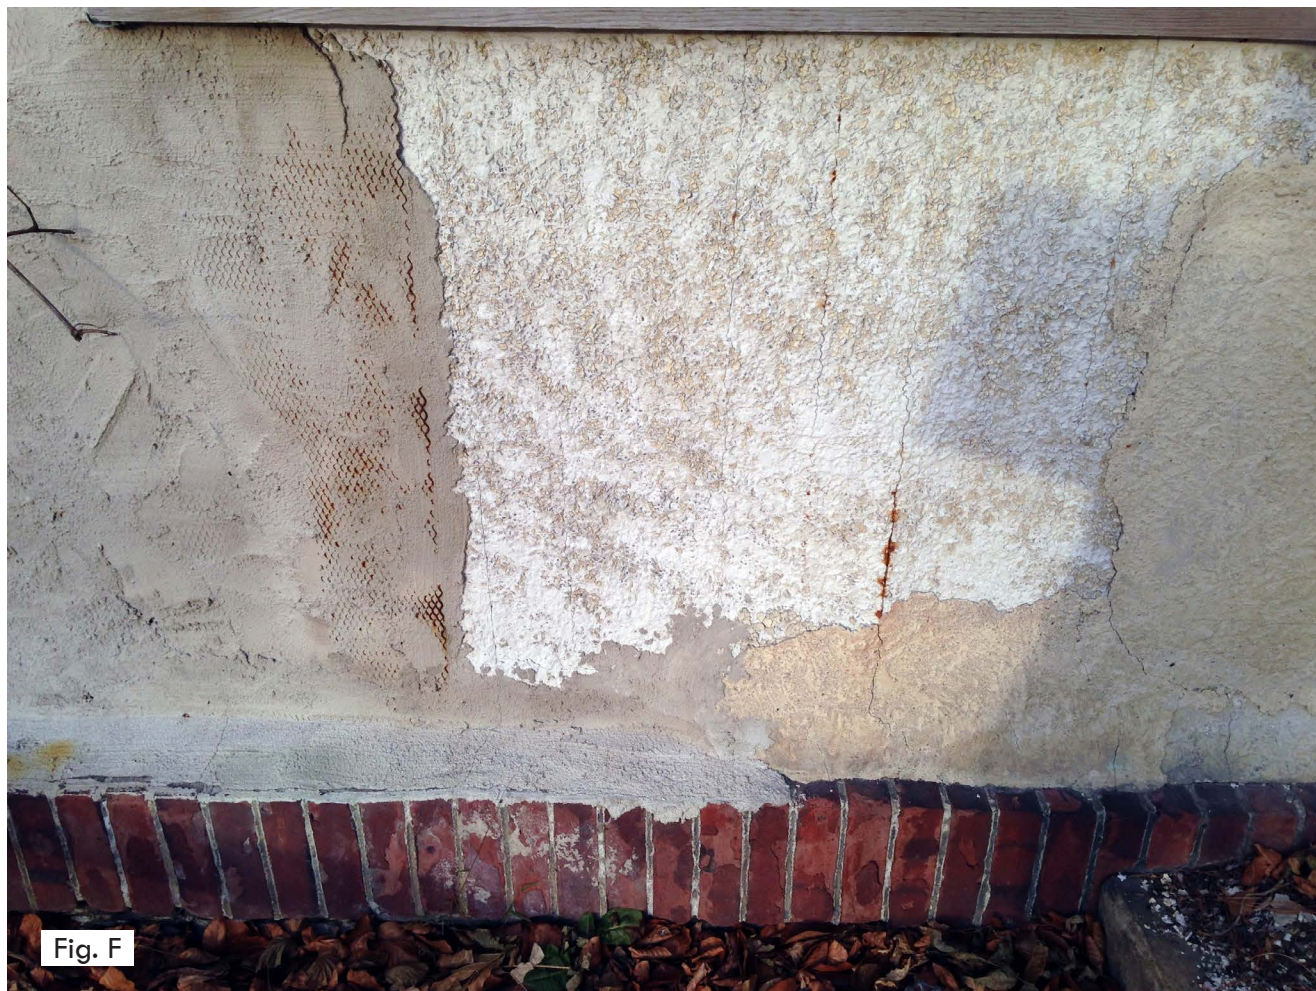
Fig. F

5. Despite patching, the stucco continues to erode and crack, exposing the undercoats to moisture. The metal lath is visible in several locations, and is corroding. FIG F

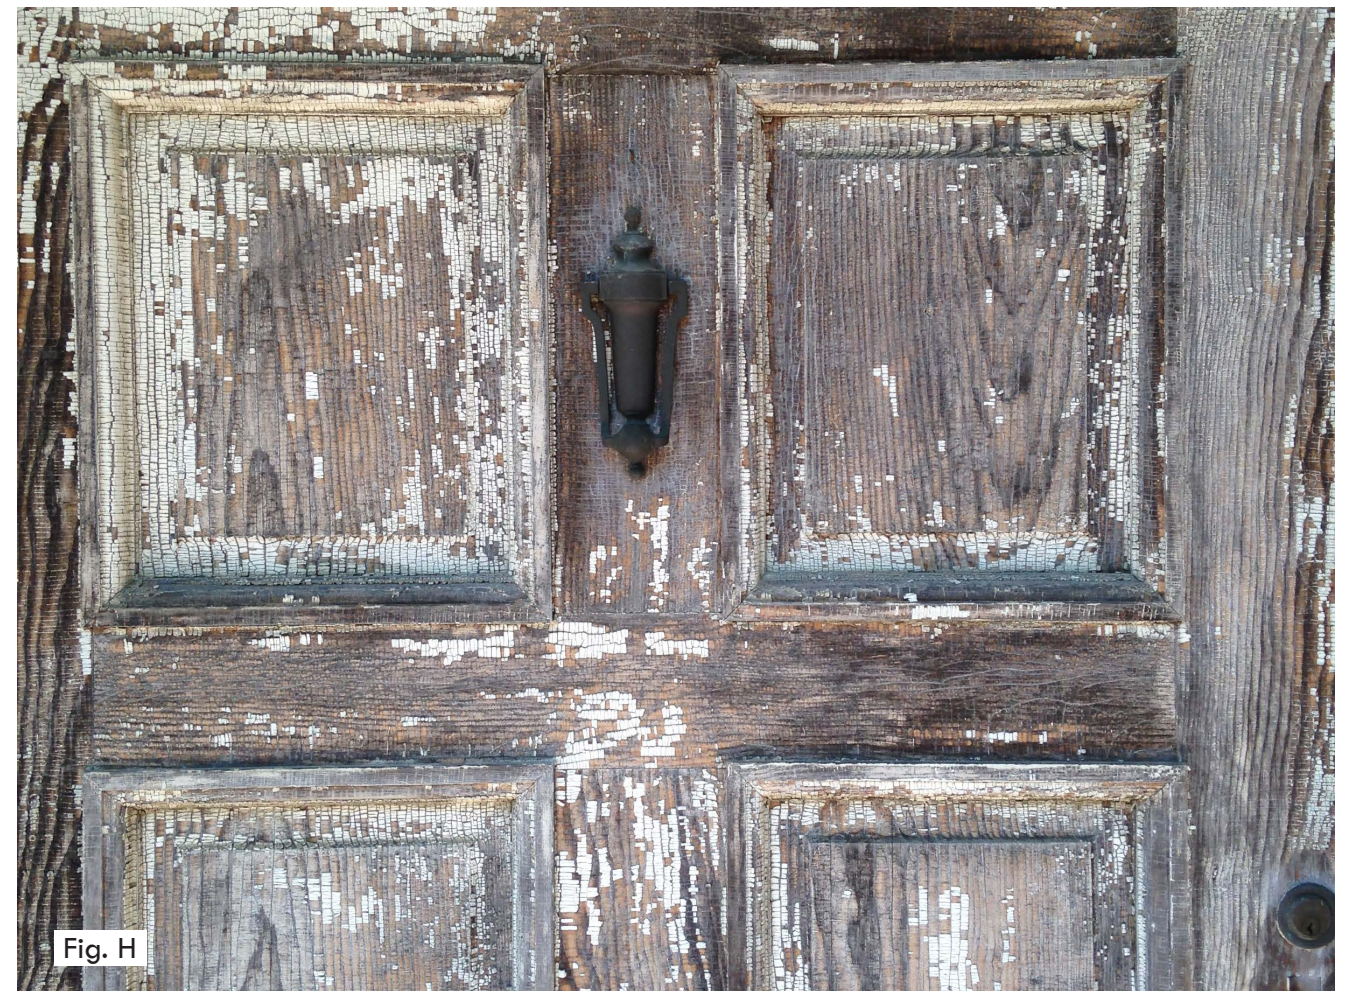
Fig. H

7. The exterior wood components appear to be in good condition, despite exposure as any paint or sealer has almost completely worn. The wood components include window trim and sills; doors, trim and jambs; shutters; the sun porch; the main entry door, pilasters, entablature, and wainscot; back entrance pergola; and loggia arches. FIG H and I

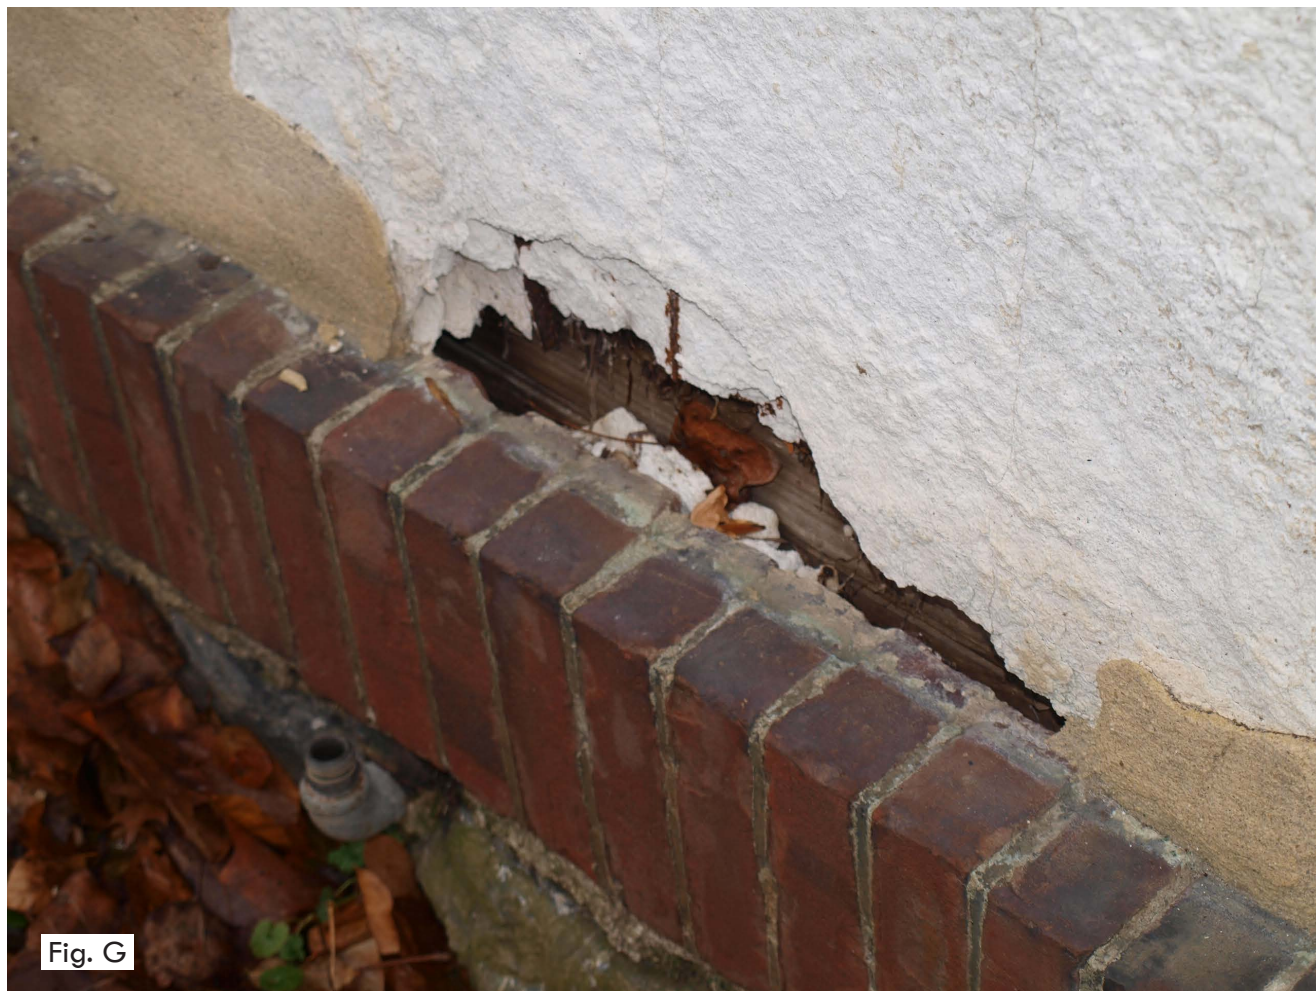
Fig. G

6. The detail at the brick grade course at the base of the building where the exterior stucco terminates at the bottom of the wall, is allowing a great deal of water to enter the exterior wall and foundation systems. This appears to be one of the major reasons for the water intrusion into the basement. FIG G

A significant oversight in the original construction of the mansion is seen in the manner in which the stucco meets and terminates the brick grade course and quoining. The stucco is in direct contact with the brick, and stepped back to create a ledge. This leaves a horizontal area of brick exposed on which water can rest and infiltrate the materials. Especially along the grade course, this is a major area of stucco failure, evidenced by the amount of patching that has been done. In order to prevent water infiltration along this seam, it is recommended to install metal flashing between the materials. The flashing would return up behind the stucco and protect the horizontal surface of the brick. In this area, the stucco would have to be removed prior to flashing, and subsequently patched.

- a. Remove an 8" high horizontal band of stucco and lath above the brick grade course.
- b. Area of repair should be squared off with a butt joint.
- c. Install 16 oz. copper flashing, attached to the exterior sheathing and protects the horizontal face of the brick course. Secure flashing to wood sheathing and tape joint.
- d. Provide replacement 3-coat stucco, of a compatible Portland cement mixture, at the base of the wall and terminating at the flashing.
