31 PRESERVATION BRIEFS

Mothballing Historic Buildings

Sharon C. Park, AIA

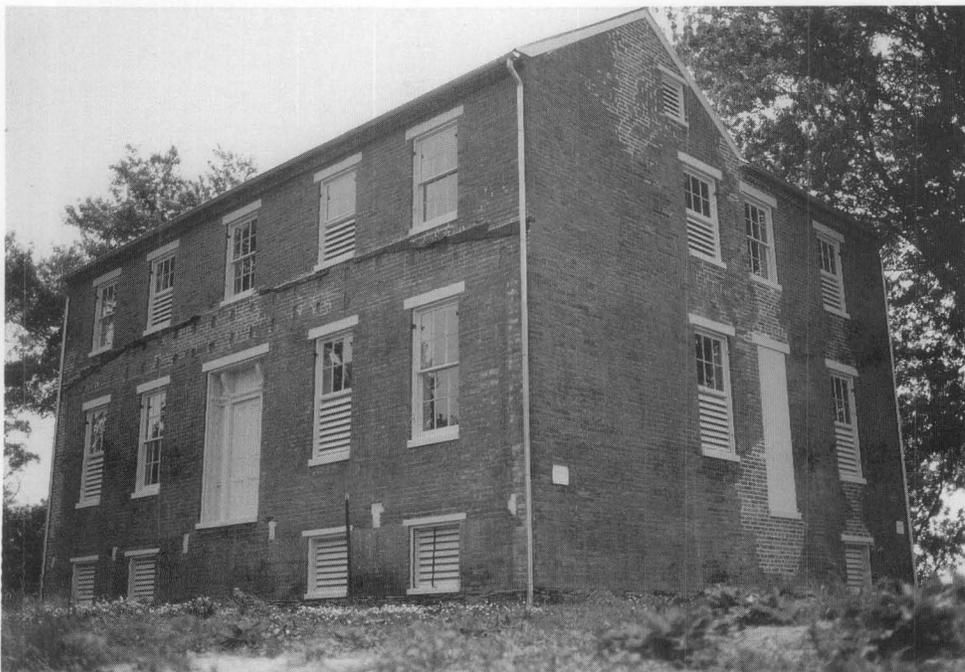
Figure 1. Proper mothballing treatment: This building has been successfully mothballed for 10 years because the roof and walls were repaired and structurally stabilized, ventilation louvers were added, and the property is maintained. Photo: Charles E. Fisher, NPS.

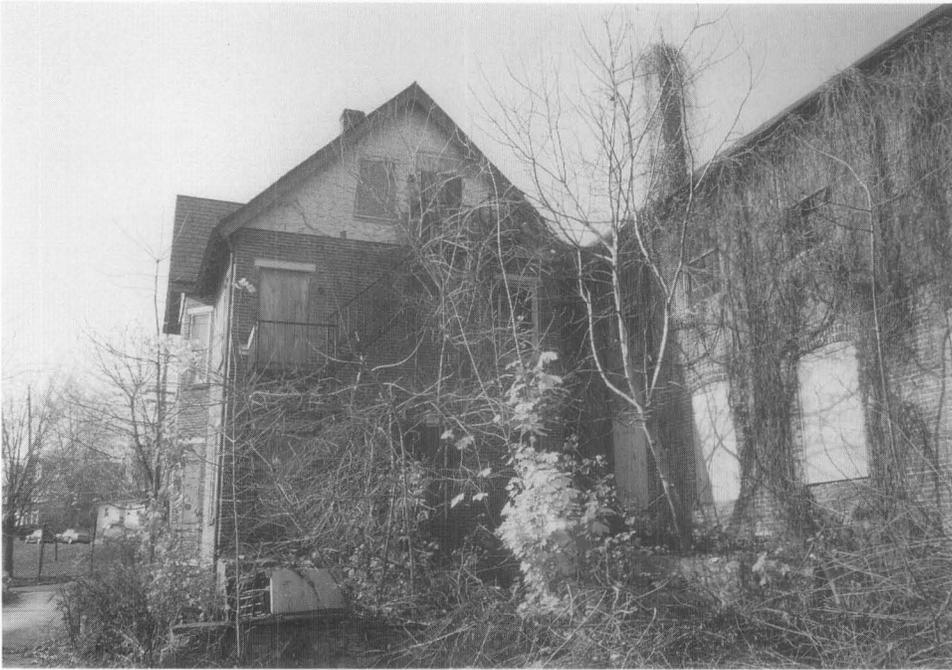
Figure 2. Improper treatment: Boarding up without adequate ventilation, lack of maintenance, and neglect of this property have accelerated deterioration. Photo; NPS file.

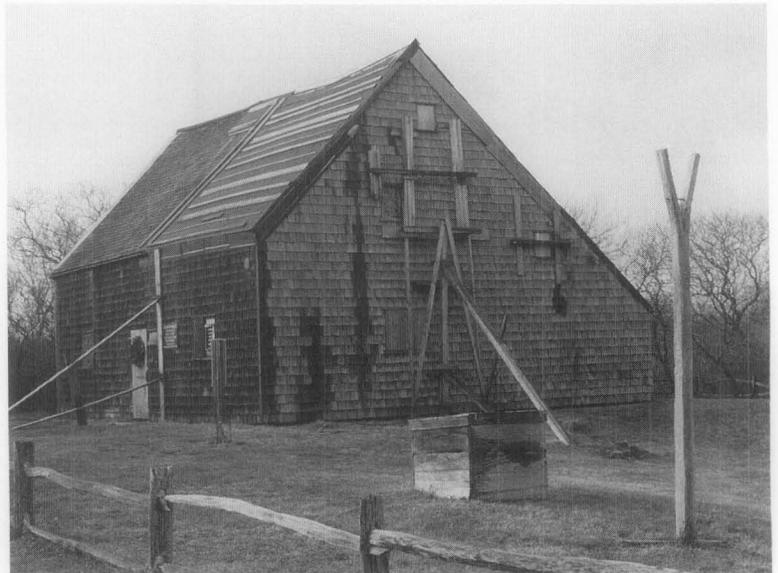
Figure 3. Buildings seriously damaged by storms or deterioration may need to be braced before architectural evaluations can be made. Jethro Coffin House. Photo: John Milner Architects.

to be structurally unsound until the condition of the structure can be fully assessed (see fig. 3). If pigeon or bat droppings, friable asbestos or other health hazards are present, precautions must be taken to wear the appropriate safety equipment when first inspecting the building. Consideration should be given to hiring a firm specializing in hazardous waste removal if these highly toxic elements are found in the building.

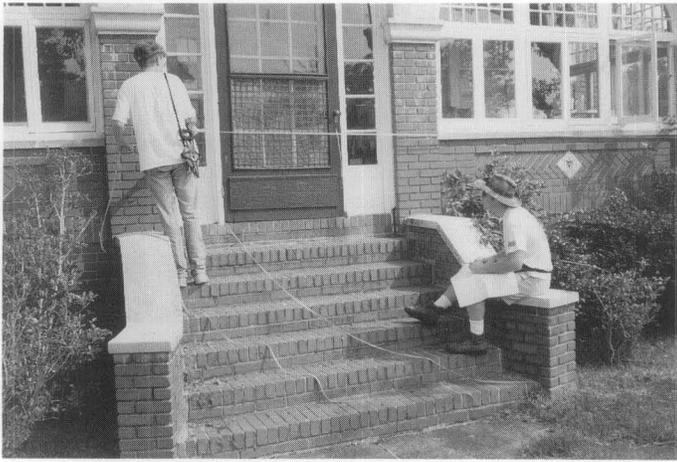
Figure 4. Documenting the building's history, preparing schematic plans, and assessing the condition of the building will provide necessary information on which to set priorities for stabilization and repair prior to securing the building. Photo: Frederick Lindstrom, HABS.

Old photographs can be helpful in identifying early or original features that might be hidden under modern materials. On a walk-through, the architect, historian, or preservation specialist should identify the architecturally significant elements of the building, both inside and out (see fig.4).

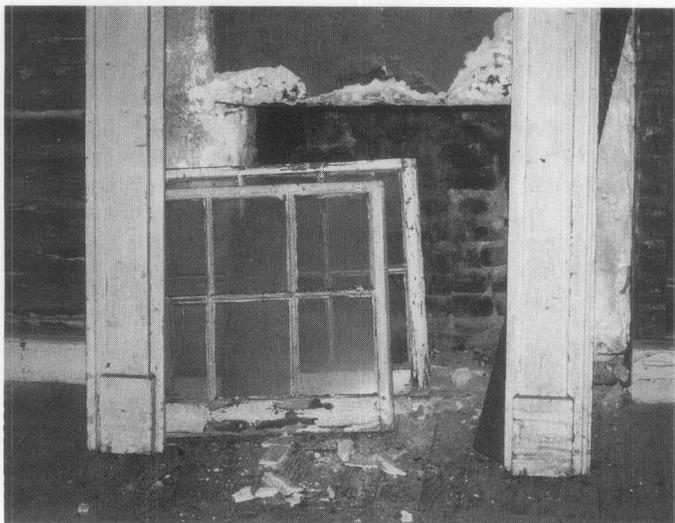
Figure 5. Loose or detached elements should be identified, tagged and stored, preferably on site. Photo: NPS files.

By understanding the history of the resource, significant elements, even though deteriorated, may be spared the trash pile. For that reason alone, any materials removed from the building or site as part of the stabilization effort should be carefully scrutinized and, if appearing historic, should be photographed, tagged with a number, inventoried, and safely stored, preferably in the building, for later retrieval (see fig. 5).

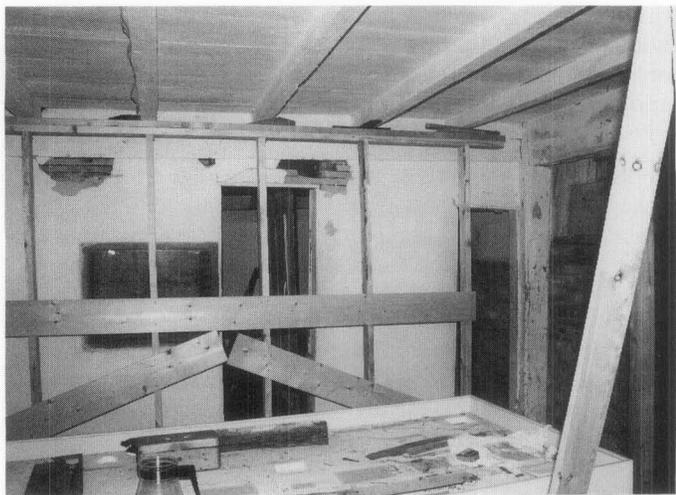
Figure 6. Interior bracing which will last the duration of the mothballing will protect weakened structural members. Jethro Coffin House. Photo: John Milner Architects.

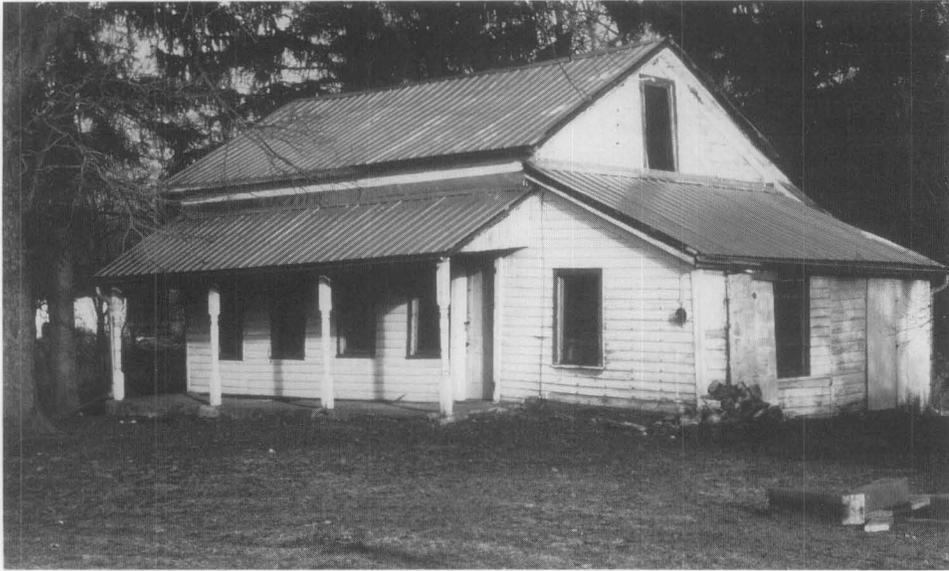
Figure 7. Non-historic materials are appropriate for mothballing projects when they are used to protect historic evidence remaining for future preservation. This lightweight aluminum channel frame and roofing covers the historic wooden shingle roof. Galvanized mesh panels secure the window openings from intrusion by raccoons and other unwanted guests. Photo: Williamsport Preservation Training Center, NPS.

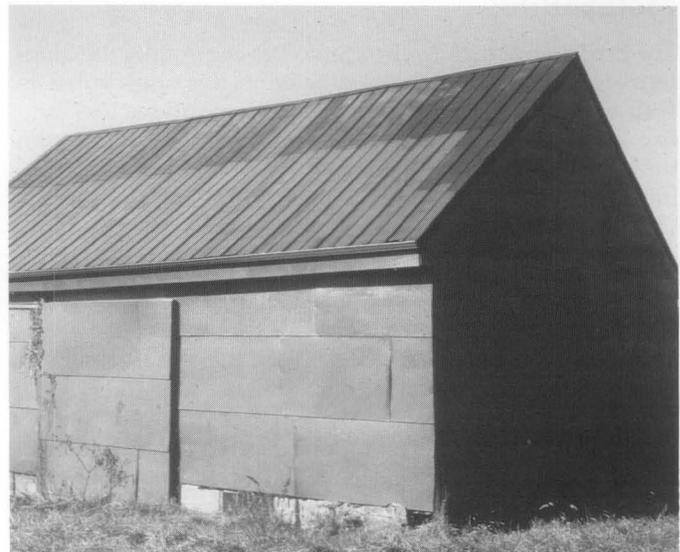
Figure 9. Severely deteriorated wooden siding on a farm building has been covered over with painted plywood panels as a temporary measure to eliminate moisture penetration to the interior. Foundation vents and loose floor boards allow air to circulate inside.

patterns or by installing panels over a frame of battens (see fig. 9). Generally, however, it is better to repair deteriorated features than to cover them over.

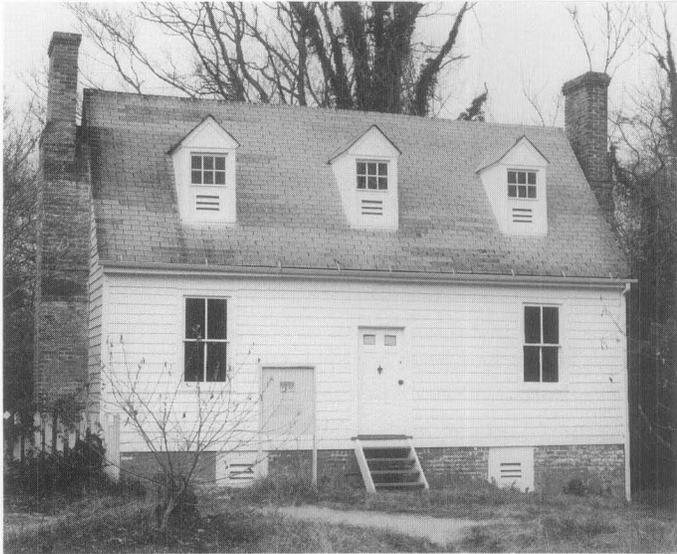
Figure 10. Regrading around the Booker Tenement at Colonial Williamsburg has protected the masonry foundation wall from excessive damp. This building has been successfully mothballed for over 10 years. Note the attic and basement vents, the temporary stairs, and the informative sign interpreting the history of this building.

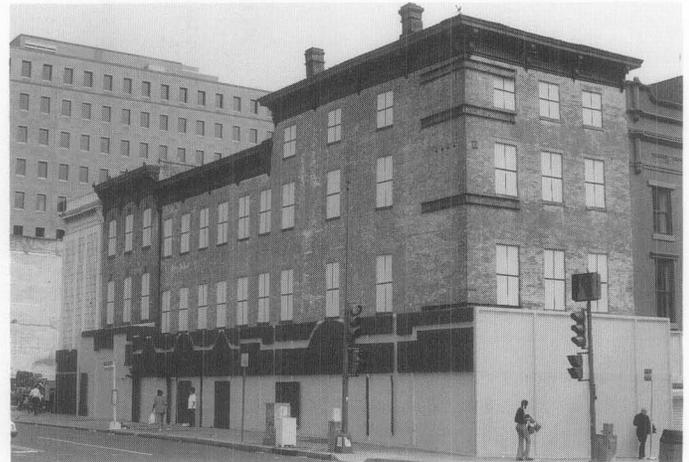
Figure 11. Urban buildings often need additional protection from unwanted entry and graffiti. This commercial building uses painted plywood panels to cover expansive glass storefronts and chain link fencing is applied on top of the panels. The upper windows on the street sides have been covered and painted to resemble 19th century sash. Photo: Thomas Jester, NPS.

Mothballed buildings are usually boarded up, particularly on the first floor and basement, to protect fragile glass windows from breaking and to reinforce entry points (see fig. 11). Infill materials for closing door and window openings include plywood, corrugated panels, metal grates, chain fencing, metal grills, and cinder or cement blocks (see fig. 12). The method of installation should not result in the destruction of the opening and all associated sash, doors, and frames should be protected or stored for future reuse.

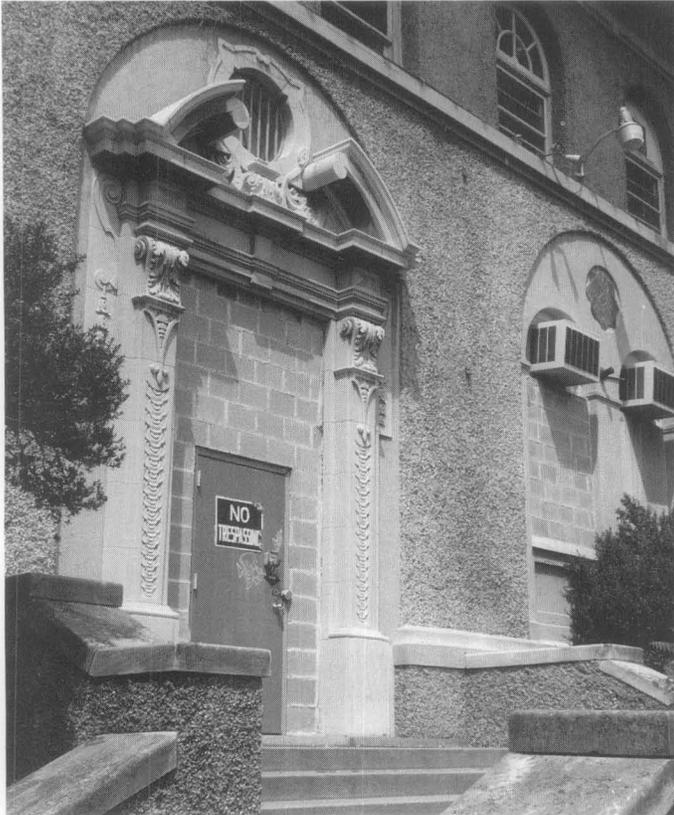
Figure 12. First floor openings have been filled with cinderblocks and doors, window sash and frames have been removed for safe keeping. Note the security light over the windows and the use of a security metal door with heavy duty locks. Photo: H. Ward Jandl, NPS.

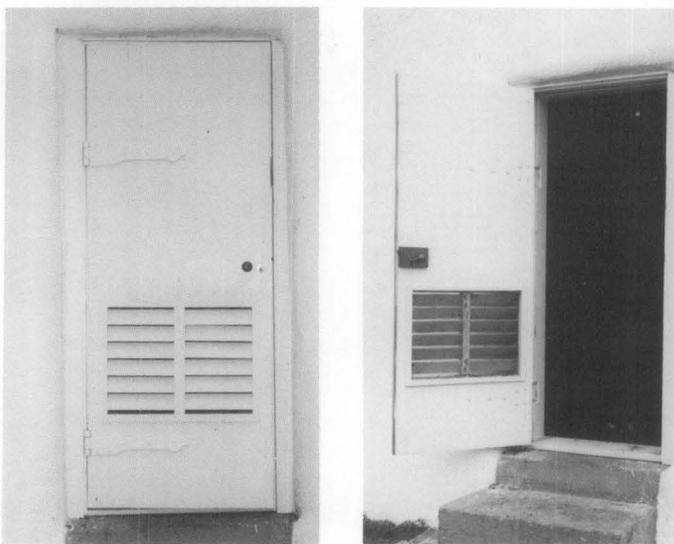
Figure 13. If historic doors would be damaged by adding extra locks, they should be removed and stored and new security doors added. At this lighthouse, the historic door has been replaced with a new door (seen both inside and outside) with an inset vent and new deadbolt locks. The heavy historic hinges have not been damaged. Photo: Williamsport Preservation Training Center, NPS.

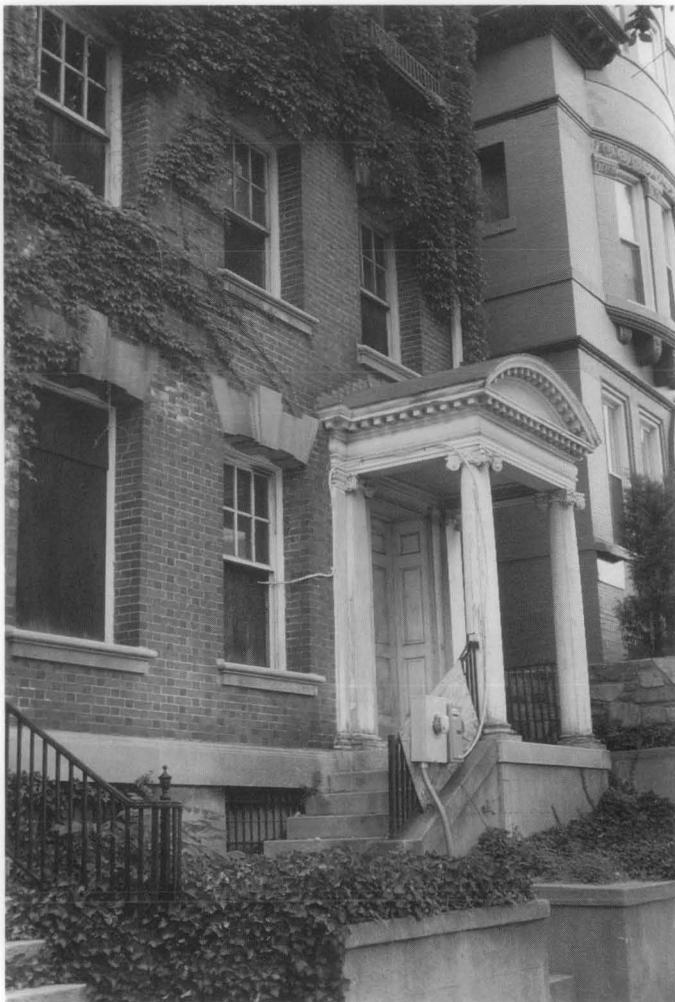
Figure 22. All systems except temporary electric have been shut off at this residence which has been mothballed over 20 years. An electric meter and 100 amp panel box have been set on a plywood panel at the front of the building. It is used for interior lighting and various alarm systems. The building, however, is showing signs of moisture problems with efflorescent stains on the masonry indicating the need for gutter maintenance and additional ventilation for the interior. The vegetation on the walls, although picturesque, traps moisture and is damaging to the masonry. Photo: H. Ward Jandl, NPS.

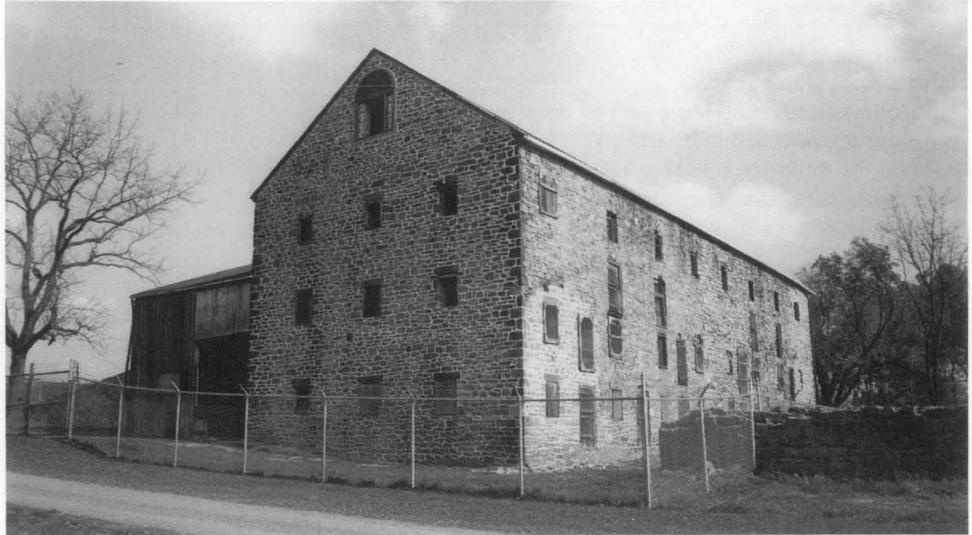
Figure 24. Once mothballed, a property must still be monitored and maintained. The openings in this historic barn has been modified with a combination of wood louvers and metal mesh panels which require little maintenance. The grounds are regularly mowed, even inside the chain link security fence. Photo: Williamsport Preservation Training Center, NPS.

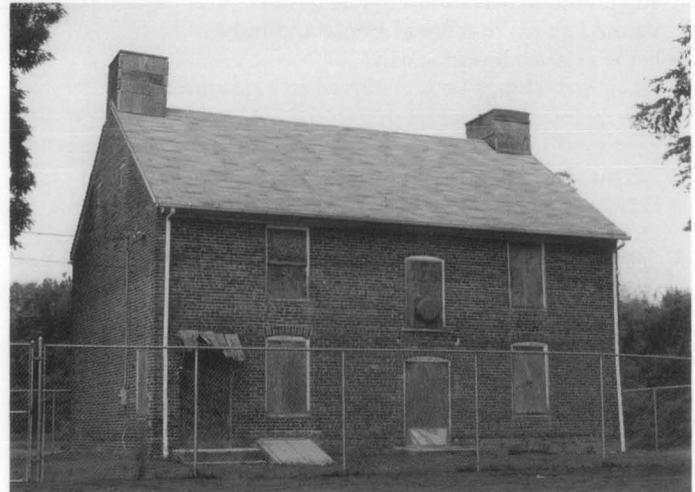
a. A view showing the exterior of the house in its mothballed condition.

Figure 25. Above is a summary of the tasks that were necessary in order to protect this significant property while restoration funds are raised. Photographs: Michael Mills; Ford Farewell Mills Gatsch Architects.

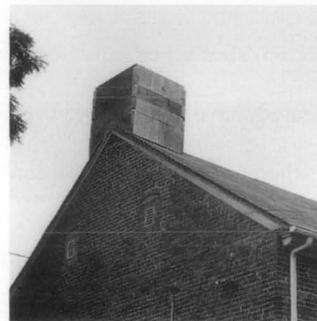
b. Plywood panels stabilize the chimneys. Note the gable vents.

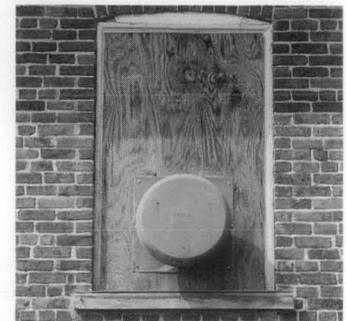
c. The exhaust fan has tamper-proof housing.
