BETHLEHEM TOWNSHIP

ARCHIBALD JOHNSTON MANSION STABILIZATION STUDY

JANUARY 2016

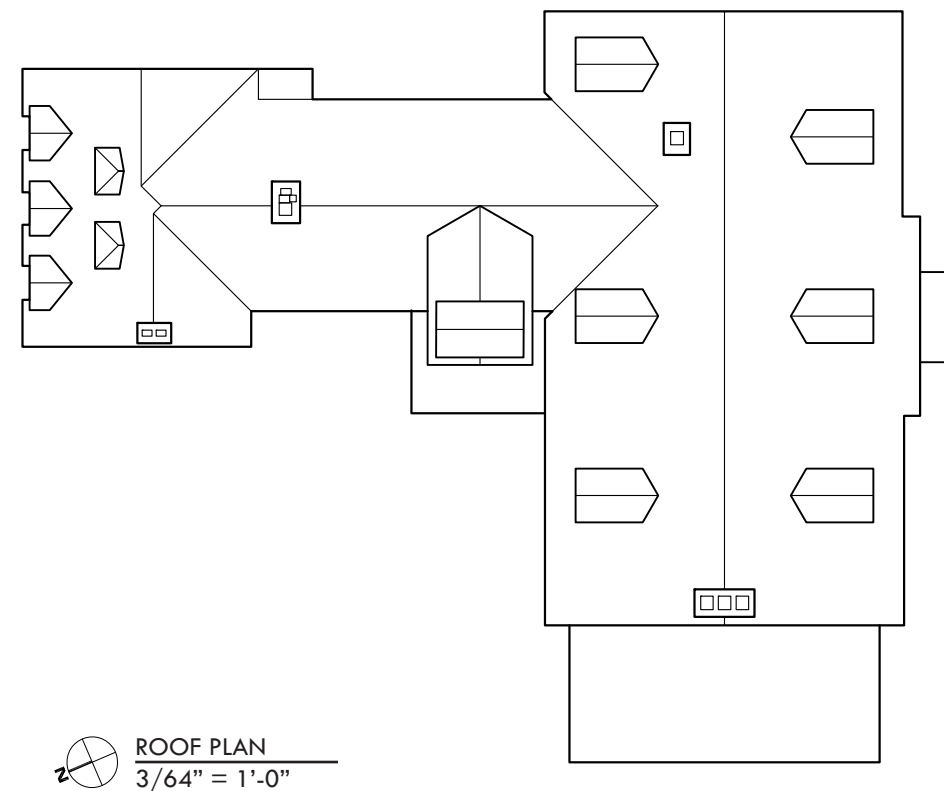
3. The slates appear to be the original slates and are beginning to deteriorate (spall). This deterioration is normal for this type of slate, however the deterioration of the slates will continue. Fig A

9. The snow guards appear to be galvanized steel. Fig. A
10. The chimney tops are in extremely poor condition, and are allowing large amounts of moisture into the building. Fig. F

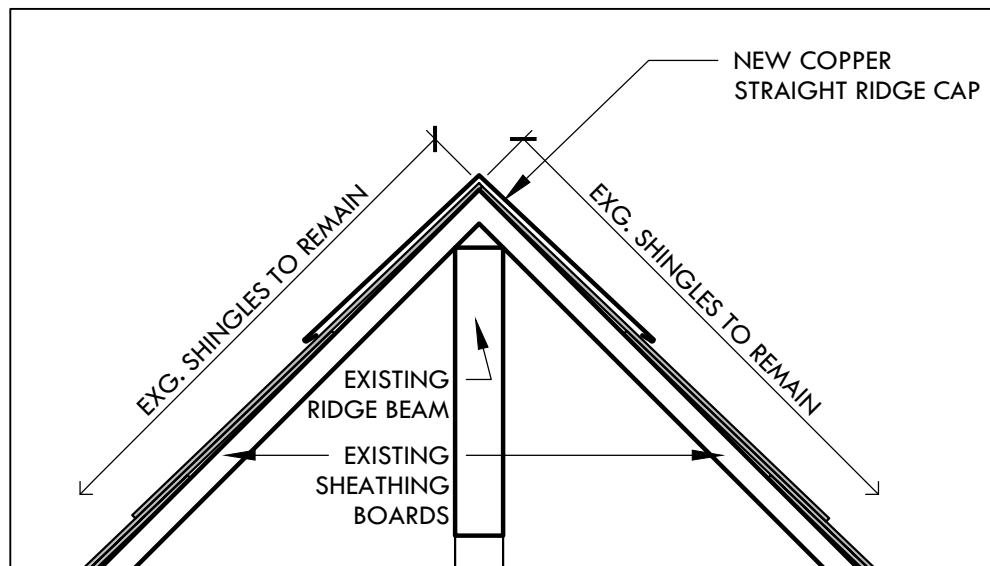
1 I.A. EXISTING "COMB RIDGE" DETAIL
 1 1/2" = 1'-0"

The slate roof utilizes a “comb ridge” that is devoid of flashing and underlayment. The ridge is protected from water infiltration by only the slight overhang of one slate that extends over the ridge and a bead of asphalt cement, to which the opposite slate abuts at its underside. This detail is not watertight, and is providing water entry directly to the interior. In portions of the primary roof, daylight can be viewed through the ridge.

Prior to addressing the ridge, any damaged or missing slate shingles, approximately 50 in count, should be replaced. In order to prevent water infiltration through the ridge, a copper ridge cap can be used to replace the “comb ridge” without replacing the roof. The combing slates along the ridge would first be removed, and a copper ridge cap would be installed in their place. The basis of design is B&B Sheet Metal, straight ridge cap.

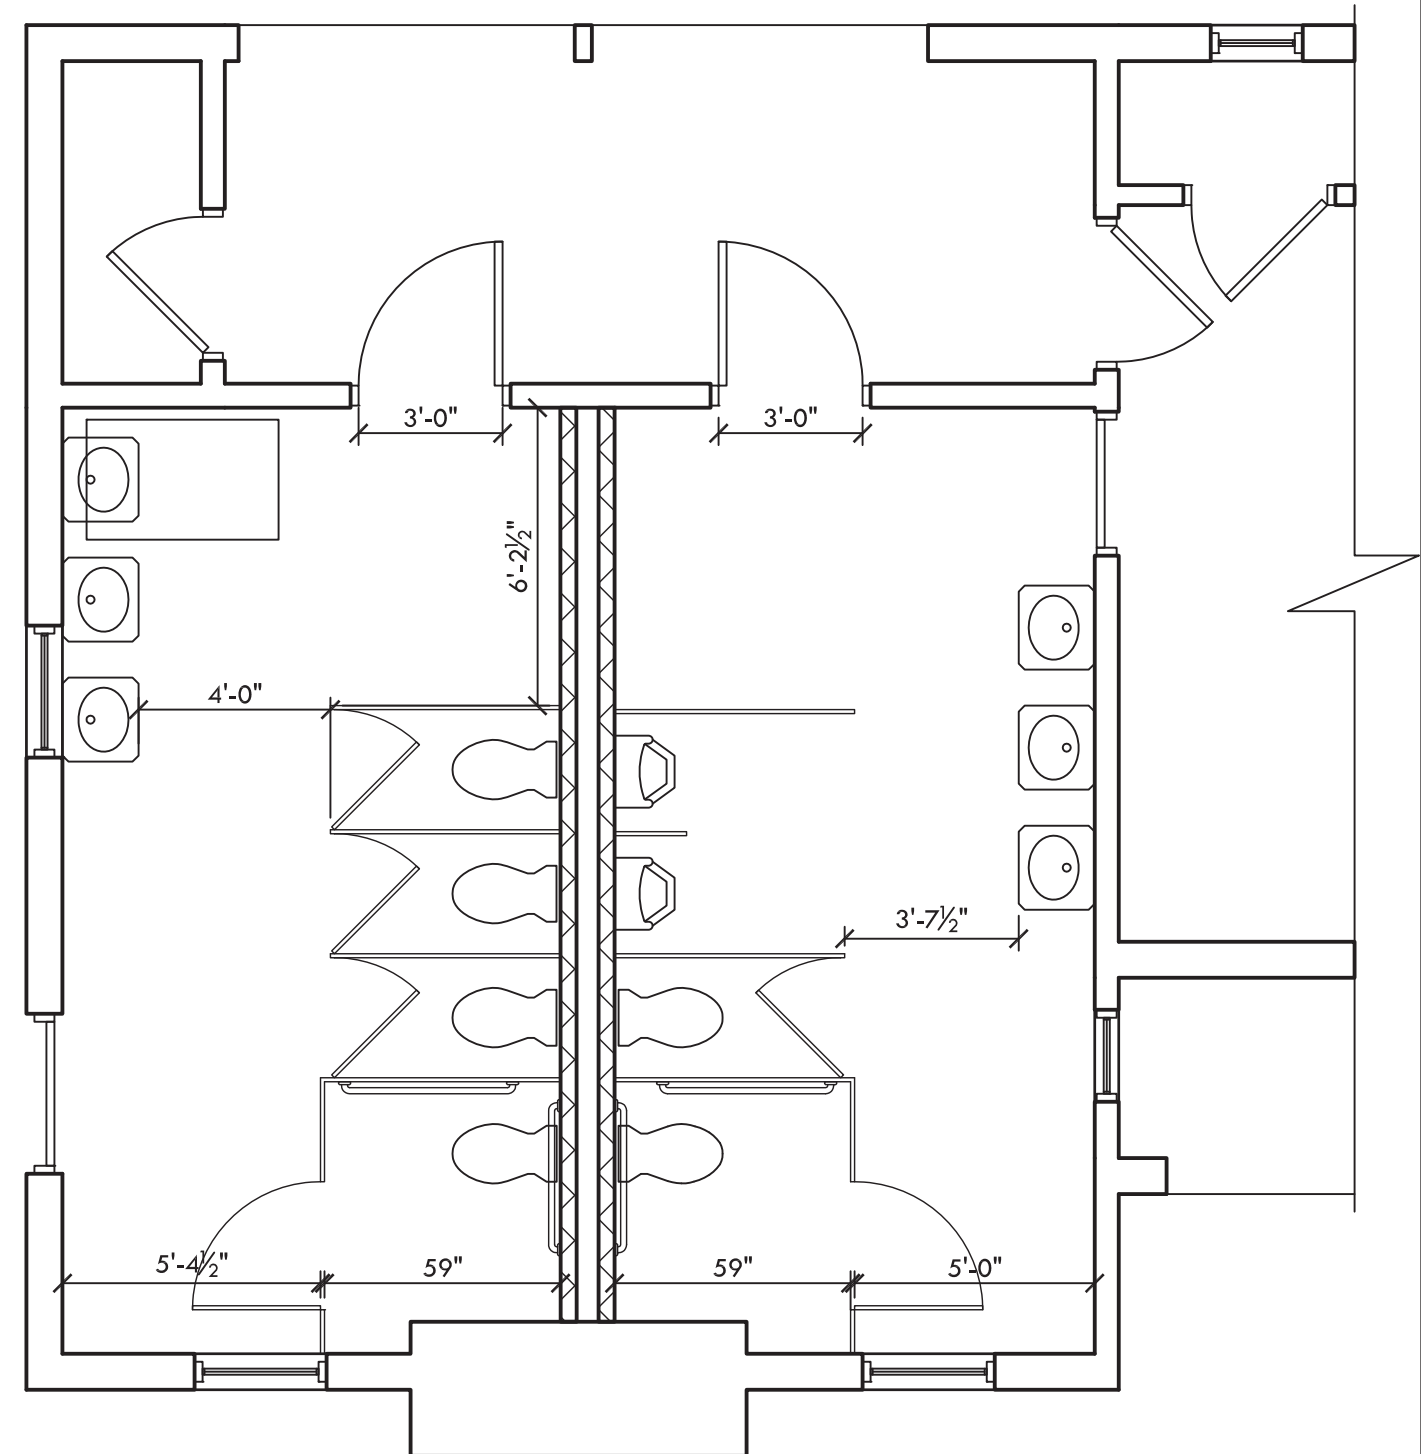
1 PROPOSED SERVANT QUARTER RESTROOMS
1/4" = 1'-0"

1. The servants' area is located in a wing off of the primary house, separated by the kitchen and service areas. It is a secondary space.
2. The area proposed for restrooms is the ground floor of the servants' quarters. It was originally used for laundry and dining for the servants, and remains a relatively open space.
3. The entire ground floor of the servants' area is approximately 21'-6" by 19'-9". The ceiling is approximately 8'-9".
4. The ground floor of the servants' area has access directly to the exterior, as well as into the servants' hall, which connects it to the rest of the house.
5. The finishes of the space include plaster ceiling and walls; partial interior wall of gypsum wall board; and vinyl flooring.

A. Servants' Area Retro-fit
